Re: W. Va. Code §22-6A-12(e) Noise, Light, Dust and Volatile Organic Compounds Study

Assessing Environmental Impacts of Horizontal Gas Well Drilling Operations (ETD-10 Project)

Pits and Impoundments Final Report

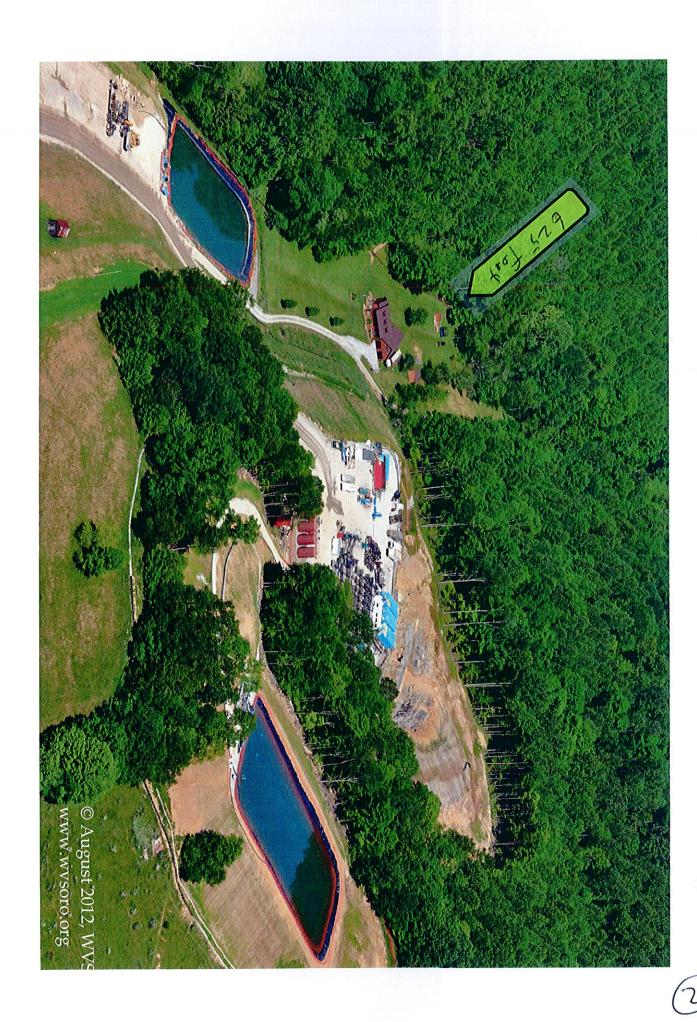
Fig 4.1c Terrain map of the Donna pad showing sampling sites (A,B,C, D) as red dots and location of DOE trailer as a yellow dot. Black circle is the 625 foot setback distance.

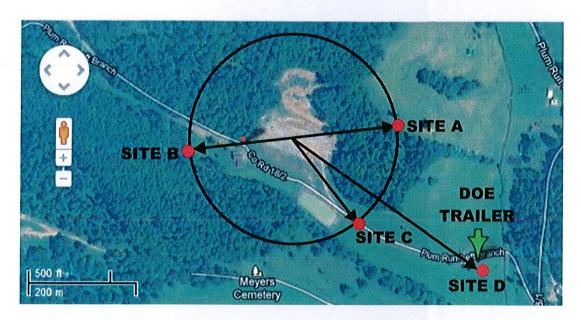
Figure 4.1b. Satellite photo of the Donna pad showing sampling sites (A,B,C, D) as red dots and location of DOE trailer as shown by the green arrow. Black circle is the 625 foot setback distance.

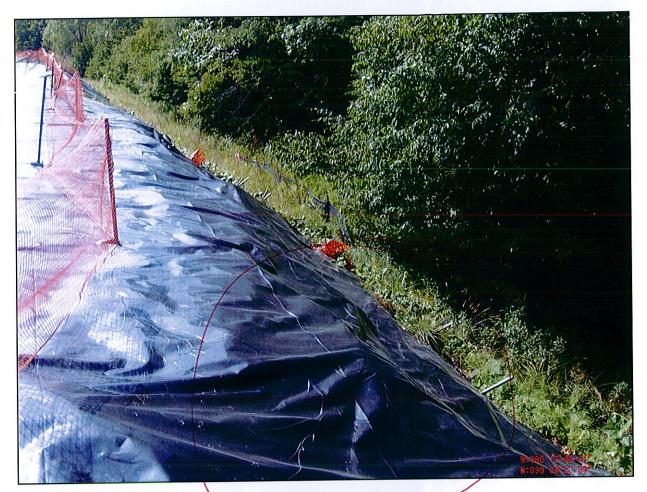
Figure 5: Bulges on Downstream Face

In Figure 5, the bulges underneath the liner indicate slope movements on the downstream face. The slope movements are evidence that the slope is no longer stable and that the ability for the structure to retain fluid has been compromised.

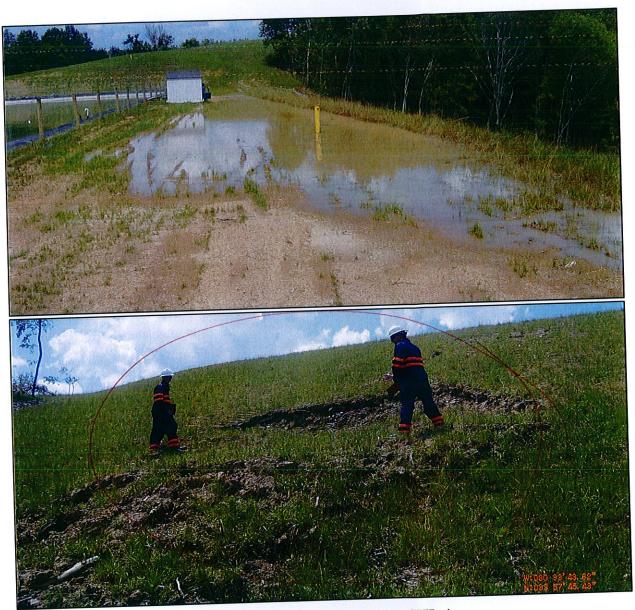
Figure 13: Slope Movement at SHL 4

Question 2 on the checklist related to the prevalence of slope movements on the downstream face. Two sites were found to have moderate slope movements, and severe slope movements were present on six sites. Figure 13 shows a severe slope movement on the SHL 4 Centralized Pit. Above the slope movement, there was a significant amount of standing water on the crest, and signs of seepage were found in the form of wet soil inside the depleted soil zone. Slope movements are a problem because the structural integrity of the downstream face has been compromised. This slope failure is an example of a shallow face failure with characteristics including a pronounced scarp, zones of depletion and accumulation, and flanks defining the width of the failed soil, which is approximately where the WVU field personnel are located.
